POST-RESTORATION EVALUATION OF TWO URBAN STREAMS IN AUSTIN,
TEXAS, USA

A Thesis

Major Subject: Water Management and Hydrological Sciences

Post-restoration Evaluation of Two Urban Streams in Austin, Texas, USA. (May 2008)

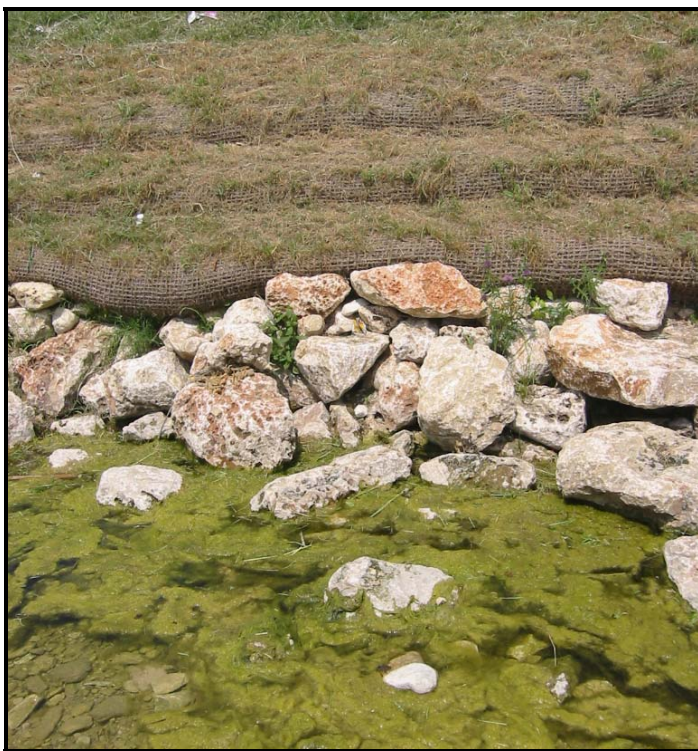
Figure 3. Example of bank stabilization on Tannehill Branch in Bartholomew Park using limestone rock and erosion control netting, May 2007.

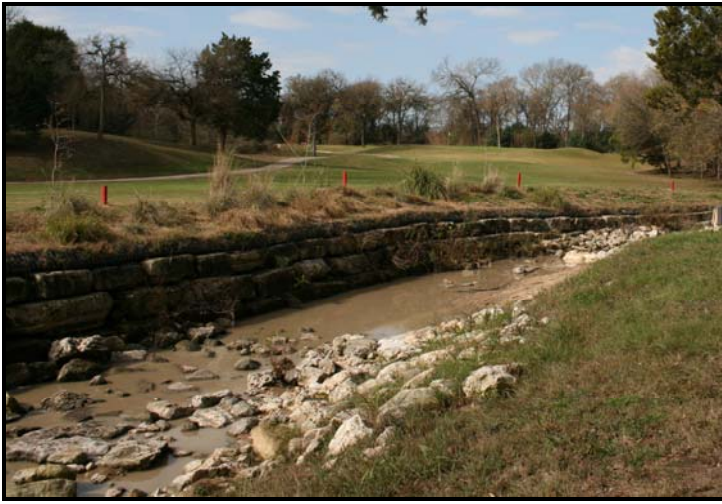
Figure 9 Tannehill Branch at Lovell Drive after restoration in 2007.

The western bank of Tannehill Branch at Lovell Drive had eroded into one of the fairways at Morris Williams Golf Course (Figure C-23). This bank was stabilized with limestone boulders that were also added to the bed to increase roughness (Figure 4). Visual analysis of 2007 photographs revealed that the boulders are intact, sand has deposited on the eastern floodplain, and vegetation has grown along the banks of the restored channel reach (Figure C-25). However, the stream does not appear to be stable. Evidence for this conclusion can be seen in the reach upstream of Lovell Drive where erosion of the steep eastern bank is undercutting property (Figure 2).

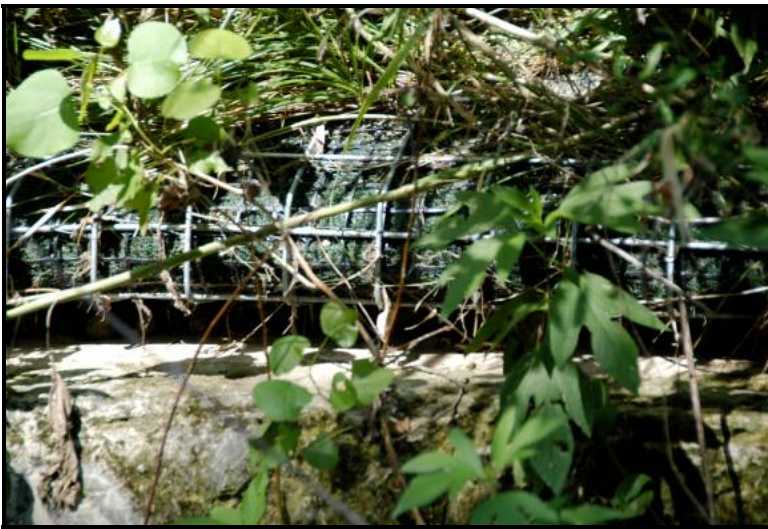
Figure 10. Fabric encapsulated soil lift with rock toe protection on banks of Tannehill Branch downstream of Lovell Drive.

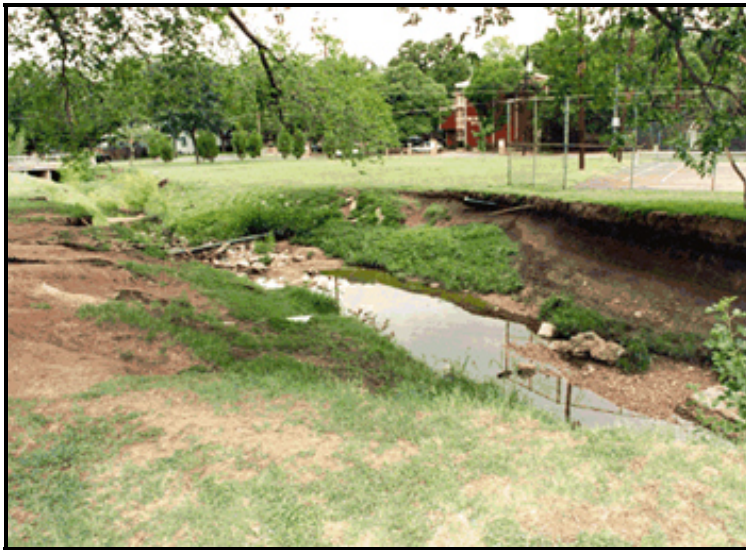
Figure 11. Waller Creek in Shipe Park before restoration c.a.1995 (City of Austin, 2001a).

Analysis of the photograph of Waller Creek in Shipe Park taken in 1995 suggests that bank failure and excess deposition occurred in the creek before restoration (Figure C-27). The only vegetation present along the channel was grasses. Comparison of this 1995 photograph to recent photographs (2007) indicate that the addition of woody vegetation and rock armoring appear to have the stabilized channel banks because there is little evidence of erosion in the ten years since restoration was completed (i.e. Figure C-30). Analysis of photographs of Waller Creek immediately upstream of Shipe Park suggests that this reach has steeper banks and less vegetation than the restored reach but appears visually stable (Figure C-33). Waller Creek immediately downstream of Shipe Park is controlled by limestone bedrock and constricted by the historic dam ~ 100 m downstream of the park (Figures 34 and 35).

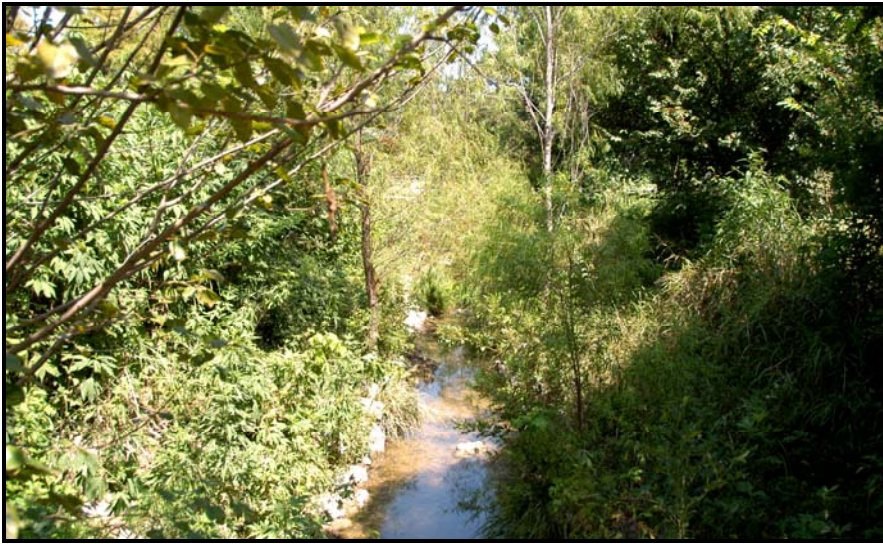
Figure 12. Waller Creek in Shipe Park after restoration in July 2007.

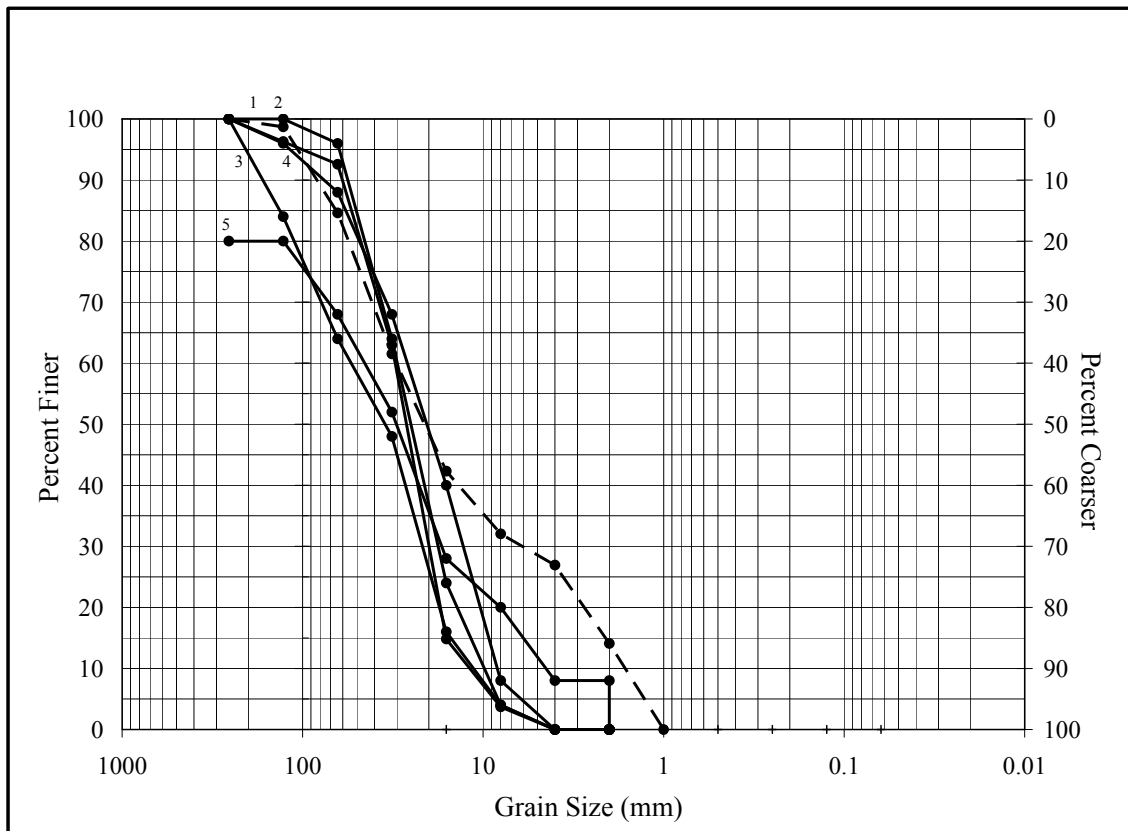
All the riffles in this reach (Figure 14) sampled before and after restoration have a similar distribution of particle sizes. Sample 6 is slightly coarser than the other riffle samples from Bartholomew Park because it was collected from the older restored section in the eastern part of the park where medium boulders (~500 mm) were used to construct riffles (Figure 15). The median sediment size for the riffles is medium gravel (Table 6). For pool bed sediment, the median diameter of sediment collected during this study ranges from 0.3 to 4.0 mm (Figure 16, Table 6). There were no pre-restoration sediment samples from pools available from this reach.

Figure 15. Cumulative frequency distribution of bed sediment in riffles, Tannehill Branch, Bartholomew Drive. The dashed line represents the sample collected before restoration by the City of Austin and the solid numbered lines represent the samples collected in 2007 from riffles 1-5 (refer to Figure 14 for location of riffles).

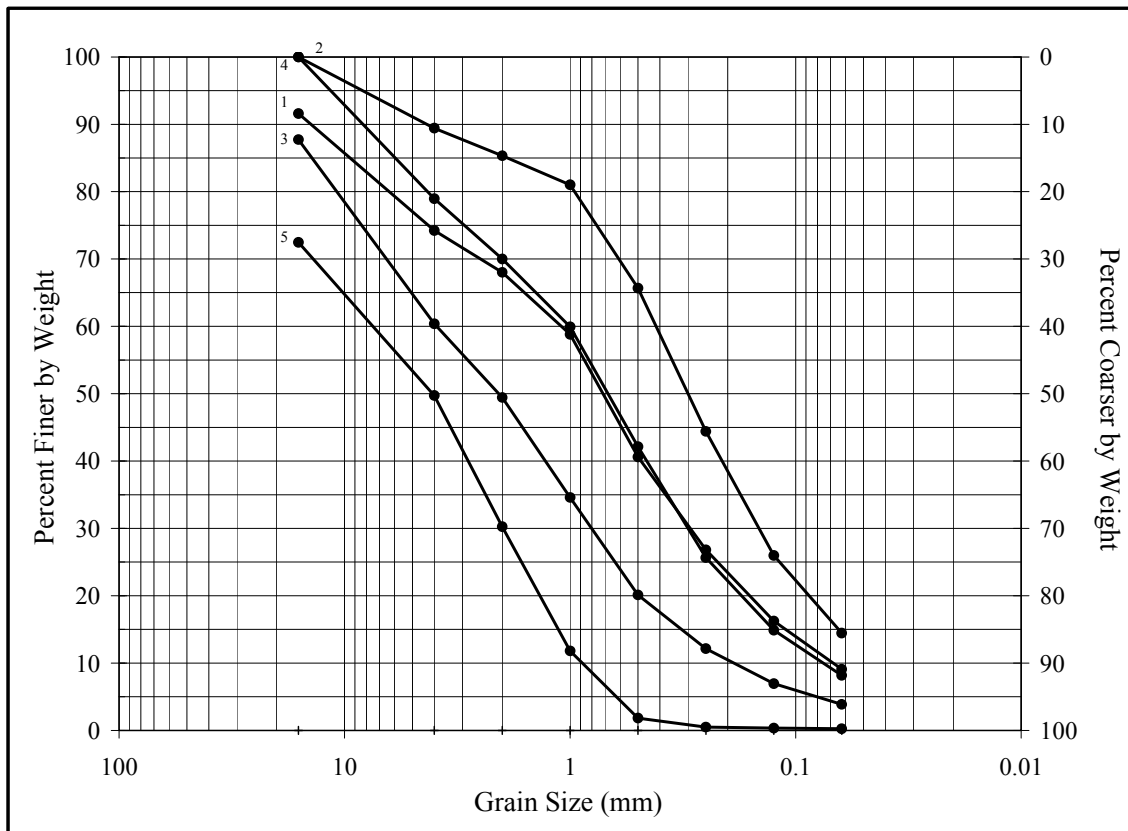
Figure 16. Cumulative frequency distribution of pool bed sediment samples, Tannehill Branch, Bartholomew Drive. The dashed line represents the sample collected before restoration by the City of Austin and the solid numbered lines represent the samples collected in 2007 from pools 1-5 (refer to Figure 14 for location of pools).

All the riffles in this reach (Figure 14) sampled before and after restoration have a similar distribution of particle sizes. Sample 6 is slightly coarser than the other riffle samples from Bartholomew Park as it was collected from the older restored section in the eastern part of the park where medium boulders (~500 mm) were used to construct riffles (Figure 15). The median sediment size for the riffles is medium gravel (Table 6). For pool bed sediment, the median diameter of sediment collected during this study ranges from 0.3 to 4.0 mm whereas the pre-restoration median diameter of sediment is 20 mm (Figure 16, Table 6).

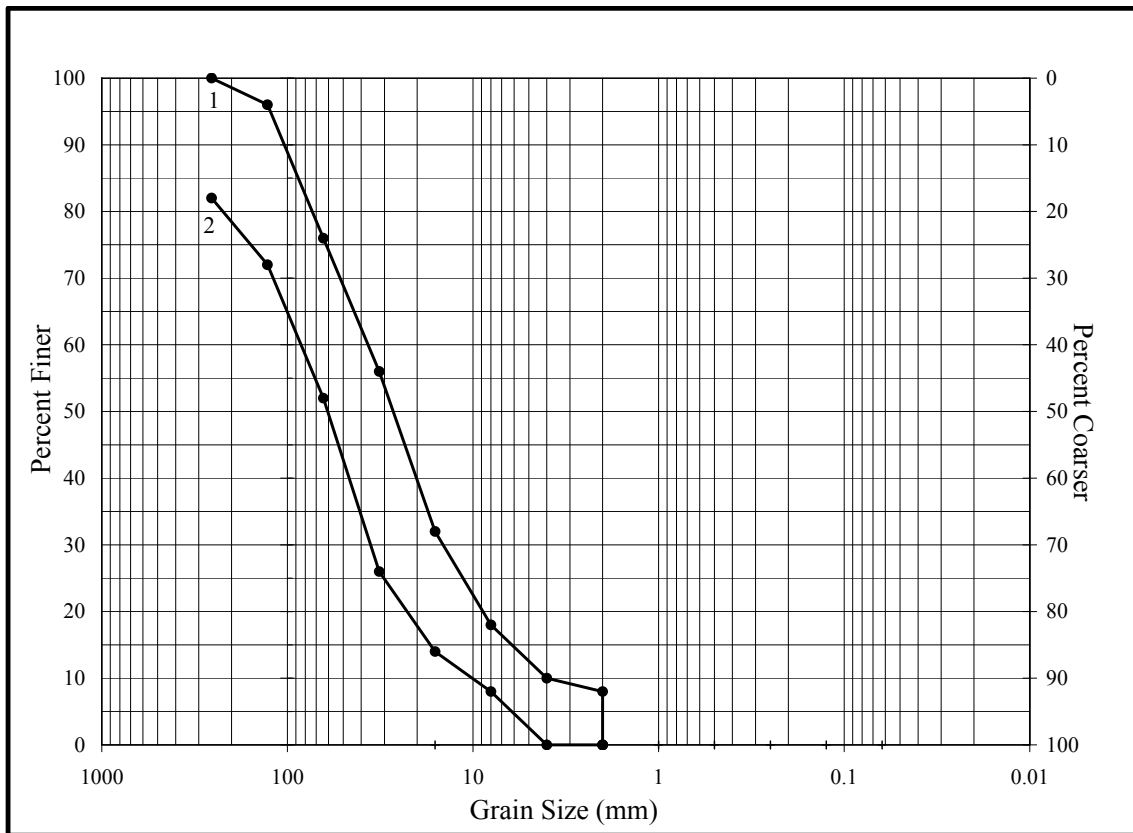
The two riffles sampled (Figure 17) at Lovell Drive are more variable than the riffles in Bartholomew Park. Riffle 2 is constructed of limestone boulders for grade control and riffle 1 consists mainly of limestone gravels (Figure 18).). The median sediment size in Pool 2 is 2.2 mm and 0.7 mm in Pool 1; however, bed sediments in both pools are finer than the pre-restoration median sediment diameter of 20 mm (Figure 19 and Table 6). There were no pre-restoration sediment samples from riffles available from this reach.

Figure 18. Cumulative frequency distribution of bed sediment in riffles, Tannehill Branch, Lovell Drive. The numbers next to the lines correspond to the riffle from which the sample was collected (Refer to Figure 17 for location of the riffles).

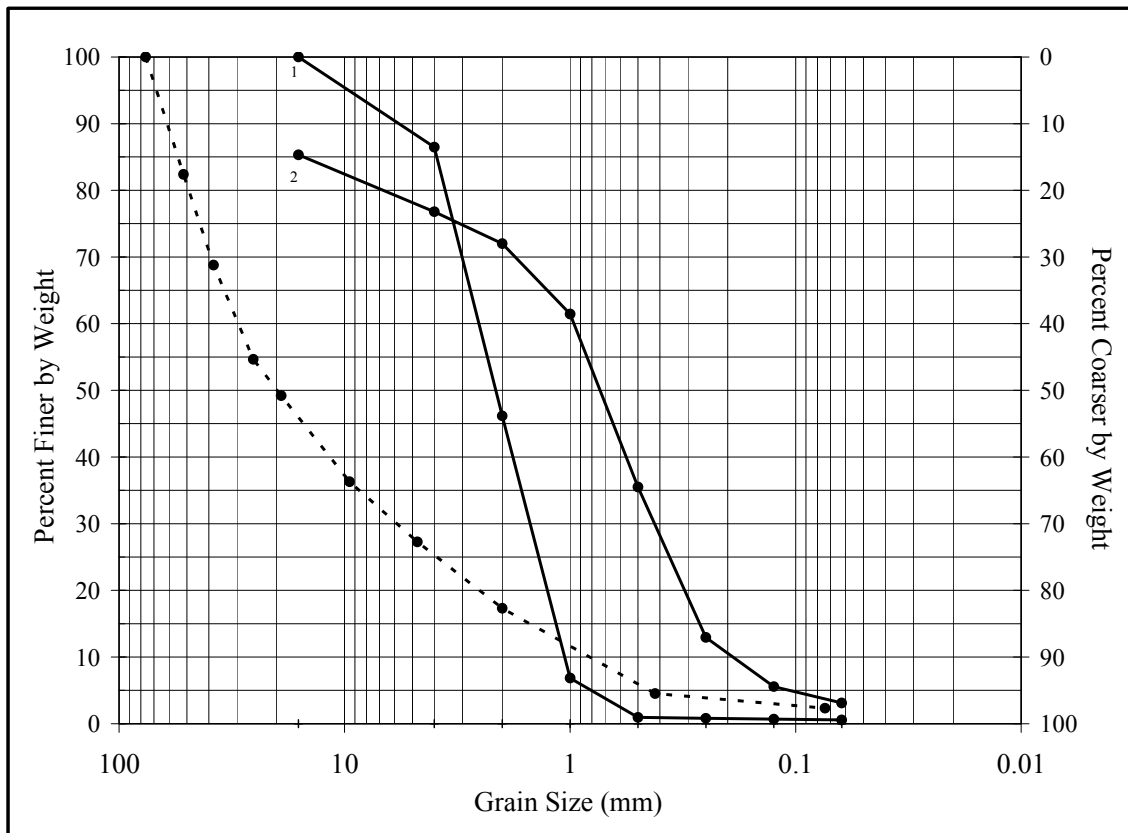
Figure 19. Cumulative frequency distribution of pool bed sediment samples, Tannehill Branch, Lovell Drive. The numbers next to the lines correspond to the pool from which the sample was collected (Refer to Figure 17 for location of the pools).

features have minimized erosion of the cut bank on this reach, they might also be the cause of excessive deposition of fine sediment in the bankfull channel (Figures 19 and 25).

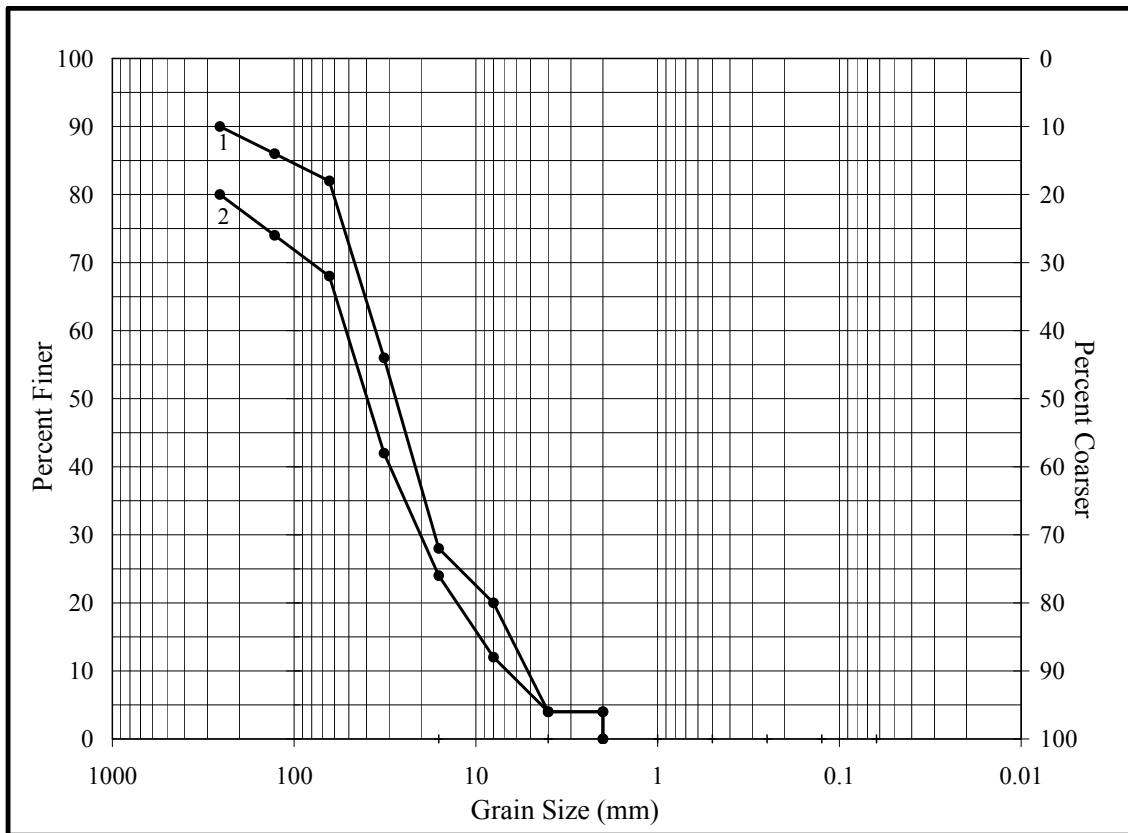
The bed of Waller Creek was overall very coarse, with a majority of the particles being gravels (Figure 20 and Table 6). The sediment in the riffles ranged from fine gravel to small boulders and sediment in the pool bed consists of fine sand to small gravel (Figures 21, 22). Riffle 2 and Pool 2 are both coarser than Riffle 1 and Pool 1 (Figures 21, 22). Pre-restoration bed sediment samples were not available from this reach.

Figure 21. Cumulative frequency distribution of bed sediment in riffles, Waller Creek, Ship Park. The numbers next to the lines correspond to the riffle from which the sample was collected (Refer to Figure 20 for location of the riffles).

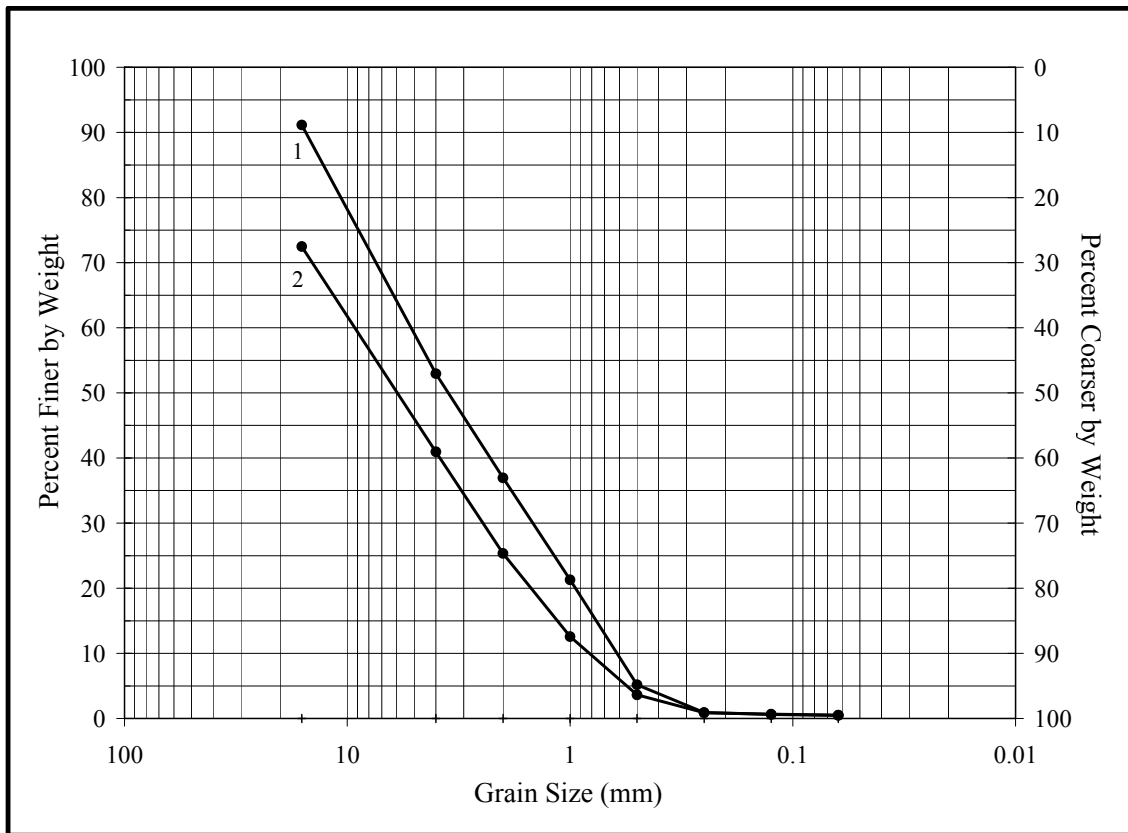
Figure 22. Cumulative frequency distribution of pool bed sediment samples, Waller Creek, Shipe Park. The numbers next to the lines correspond to the pool from which the sample was collected (Refer to Figure 20 for location of the pools).

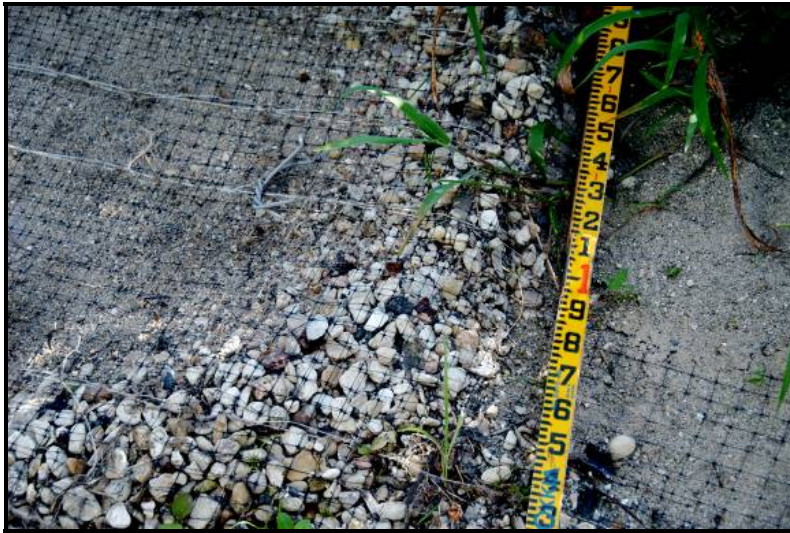
Figure 24. Gravel moving underneath erosion control netting on stream bank of Tannehill Branch in Bartholomew Park, 2007.

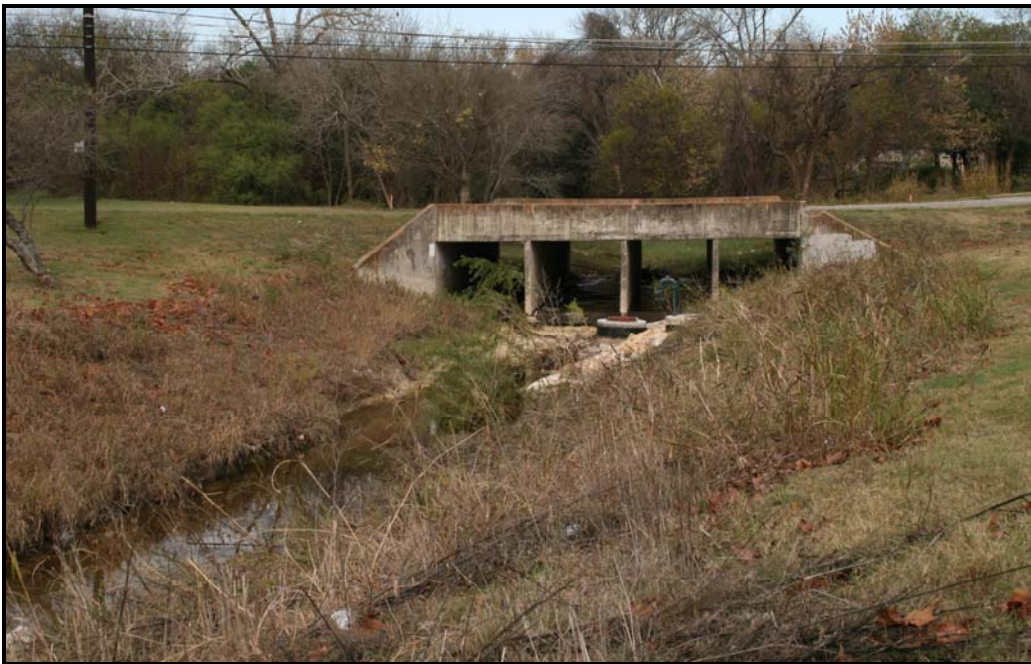
Figure C-1. Tannehill Branch in Bartholomew Park facing Berkman Drive before restoration, 2003 (Courtesy M. Rotar).

Tannehill Branch in Bartholomew Park showed evidence of severe bank erosion before restoration in 2003 (i.e. Figure C-1). In addition to steep, unstable banks, this reach exhibited signs of downcutting (Figure C-13) and gully erosion (Figure C-15), all of which degraded the appearance of the park (Figure C-17) and minimized recreational opportunities (Figure C-19) in the park. Comparison of photographs from 2003 with current photographs suggests that the restoration features installed in 2006 have improved stability of the banks (i.e. Figures C-5 and C-6) and minimized downcutting (Figure C-14). Deposition has occurred in the gullies but headward erosion continues toward the road parallel to the park (51st Street, Figure C-16).

Tannehill Branch in Bartholomew Park showed evidence of severe bank erosion before restoration in 2003 (i.e. Figures C-1). In addition to steep, unstable banks, this reach exhibited signs of downcutting (Figure C-13) and gully erosion (Figure C-15), all of which degraded the appearance of the park (Figure C-17) and minimized recreational opportunities (Figure C-19) in the park. Comparison of photographs from 2003 with current photographs suggest the restoration features installed in 2006 have improved

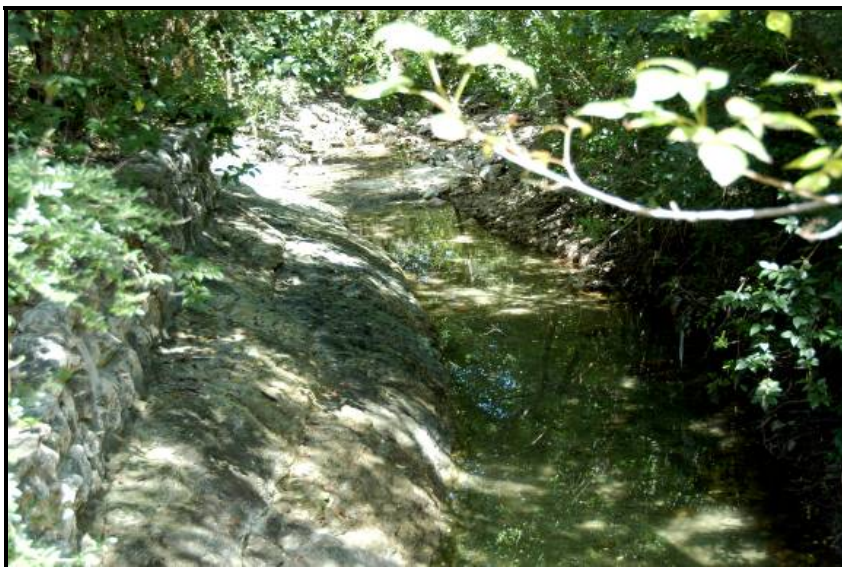
Figure C-34. Waller Creek downstream of Shipe Park, July 2007.

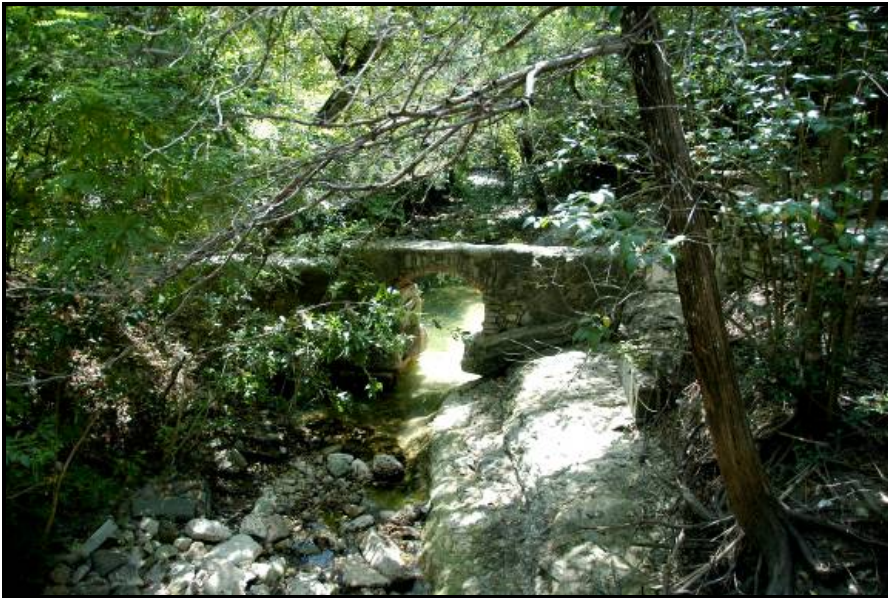
Figure C-35. Dam from 1800s behind Elisabet Ney Museum on Waller Creek, downstream of Shipe Park, July 2007.
